CECW-EG	Department of the Army U.S. Army Corps of Engineers	EM 1110-2-2002
Engineer Manual 1110-2-2002	Washington, DC 20314-1000	30 June 1995
	Engineering and Design	
	EVALUATION AND REPAIR OF CONCRETE STRUCTURES	
	Distribution Restriction Statement Approved for public release; distribution is unlimited.

## Engineering and Design EVALUATION AND REPAIR OF CONCRETE STRUCTURES

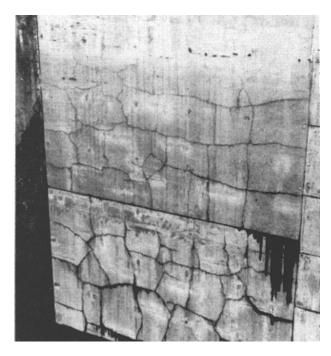
Figure 2-5. Pattern cracking caused by restrained volume changes

- (a) Surface appearance of cracks. The surface appearance of cracks can give the first indication of the cause of cracking. Pattern cracks (Figures 2-5 through 2-7) are rather short cracks, usually uniformly distributed and interconnected, that run in all directions. Pattern cracking indicates restraint of contraction of the surface layer by the backing or inner concrete or possibly an

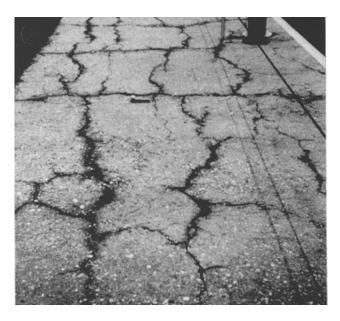
Figure 2-6. Pattern cracking resulting from alkali-slice reaction

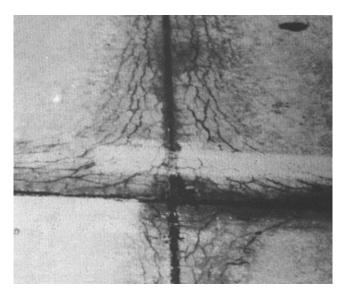
Figure 2-8. D-cracking in a concrete pavement

increase of volume in the interior of the concrete. Other terms used to describe pattern cracks are map cracks, crazing, and checking (see Glossary, Appendix B, for definitions). Another type of pattern crack is D-cracking. Figure 2-8 shows typical D-cracking in a concrete pavement. D-cracking usually starts in the lower part of a concrete slab adjacent to joints, where moisture accumulates, and progresses away from the corners of the slab. Individual cracks (Figures 2-9 through 2-11) run in definite directions and may be multiple cracks in parallel at definite intervals. Individual cracks indicate tension in the direction perpendicular to the cracking. Individual cracks are also frequently referred to as isolated cracks. Several terms may be used to describe the direction that an individual or isolated crack runs. These terms include diagonal, longitudinal, transverse, vertical, and horizontal.

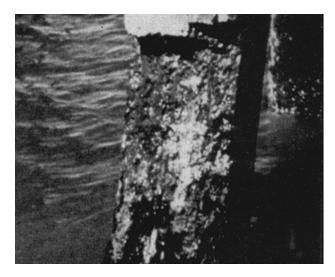
Figure 2-13. Disintegration of concrete caused by exposure to acidic water

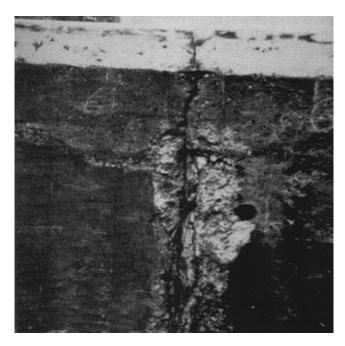
Figure 2-15. Disintegration at a monolith joint as a result of repeated cycles of freezing and thawing and barge impact

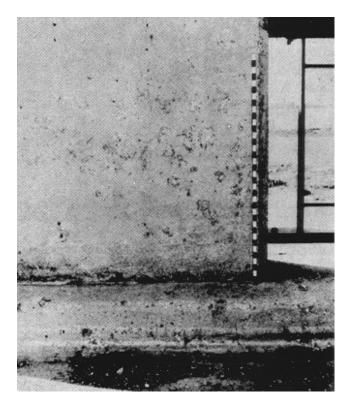
Figure 2-16. Light scaling

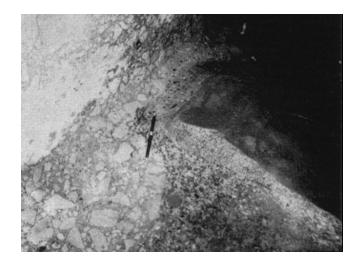
Figure 2-20. Smooth, worn, abraded concrete surface caused by abrasion of waterborne debris

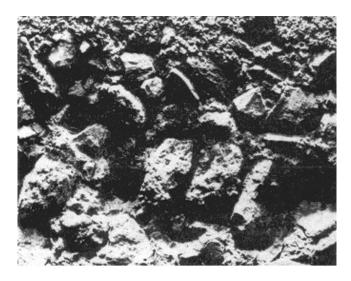
Figure 2-21. Rough, pitted concrete surface caused by cavitation

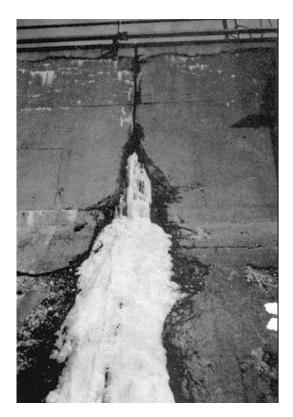
Figure 2-28. Water seepage through joint

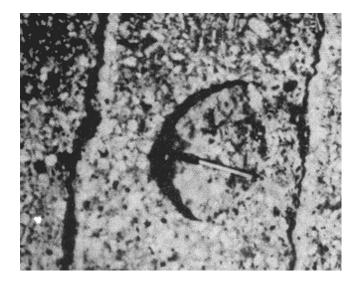
Figure 2-29. Small spall

- (8) Spalling. Spalling is defined as the development of fragments, usually in the shape of flakes, detached from a larger mass. As noted in paragraph 2-3a(3), spalling differs from disintegration in that the material being lost from the mass is concrete and not individual aggregate particles that are lost as the binding matrix disintegrates. The distinction between these two symptoms is important in any attempt to relate symptoms to causes of concrete problems. Spalls can be categorized as follows:
- (a) Small spall. Not greater than 20 mm (0.8 in.) in depth nor greater than 150 mm (6 in.) in any dimension (Figure 2-29).

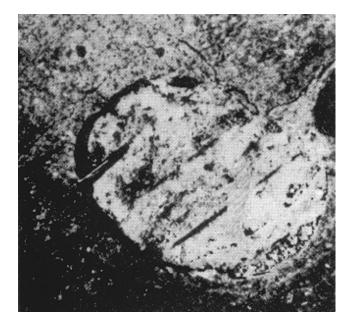
Figure 2-30. Large spall

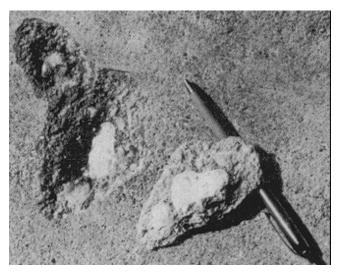
Figure 2-31. Popout

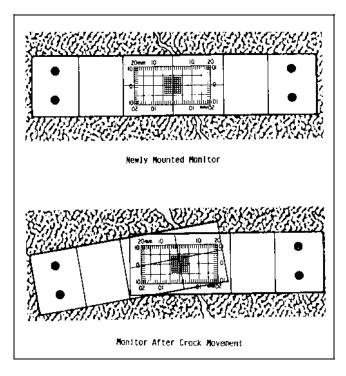
Figure 2-33. Crack monitor

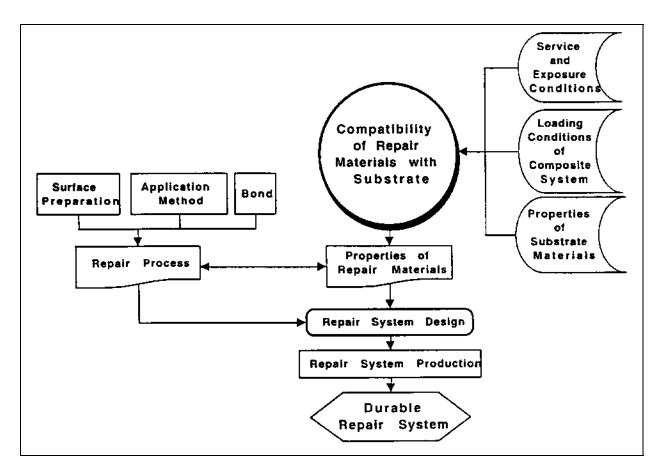
Figure 4-1. Factors affecting the durability of concrete repair systems (Emmons and Vaysburd 1995)

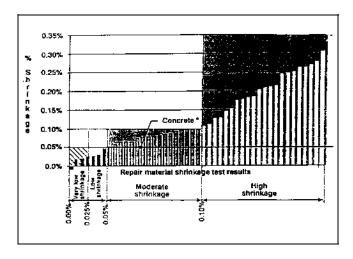
Figure 4-2. Classification of repair materials based on drying shrinkage (Emmons and Vaysburd 1995)

- (b) The ASTM C 157 (Modified) test method has been used to evaluate the drying shrinkage of 46 commercially available patching materials (Gurjar and Carter 1987). Test results at 28 days were sorted and categorized by Emmons and Vaysburd (in preparation) as shown in Figure 4-2. Shrinkage of conventional concrete

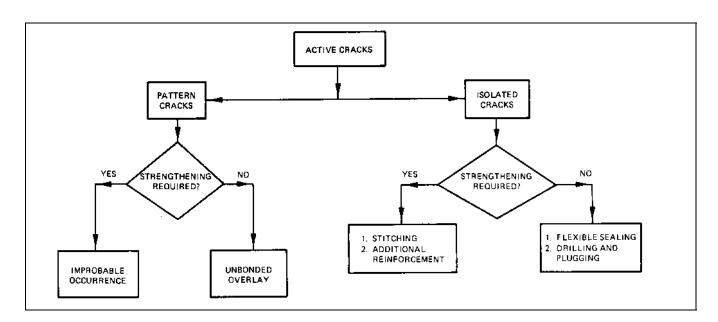
Figure 4-3. Selection of repair method for active cracks (after Johnson 1965)

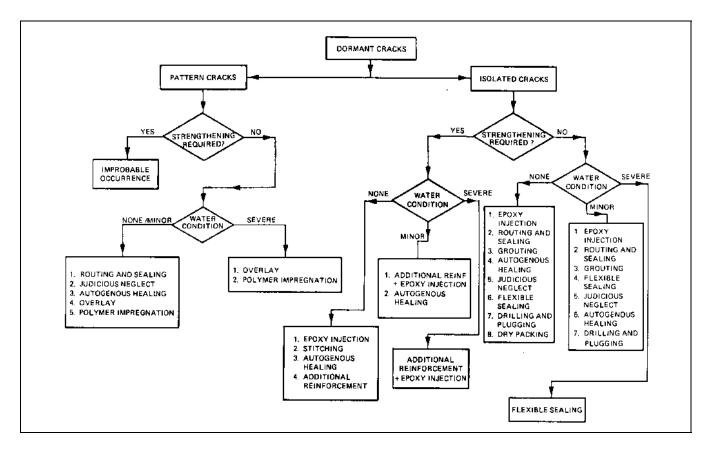
Figure 4-4. Selection of repair method for dormant cracks (after Johnson 1965)

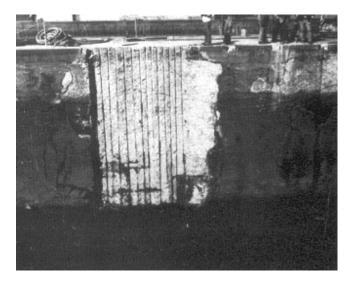
Figure 5-1. Surface removal of deteriorated concrete by explosive blasting

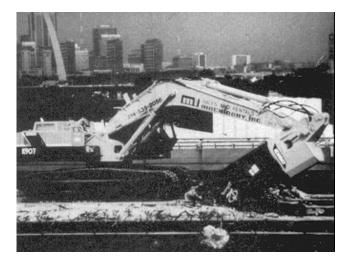
Figure 5-2. Boom-mounted concrete crusher

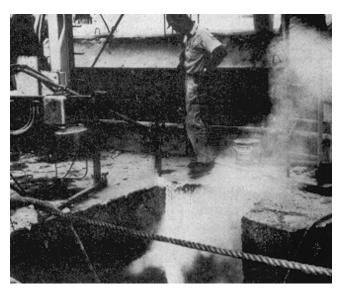
Figure 5-5. Powder torch

- (5) Thermal cutting. Thermal-cutting methods are applicable for making cutouts through heavily reinforced decks, beams, walls, and other reinforced members where site conditions allow efficient flow of molten concrete from cuts. Flame tools (Figure 5-5) are typically employed for cutting depths of 600 mm (24 in.) or less, and lances (Figure 5-6), for greater depths. Thermal cutting tools are of limited commercial availability and are costly to use. The concrete that remains has a layer of thermal damage with more extensive damage occurring around steel reinforcement. Personnel must be protected from heat and hot flying rock produced by the cutting Additional safety precautions are required because of the hazards associated with the storage, handling, and use of compressed and flammable gases. The

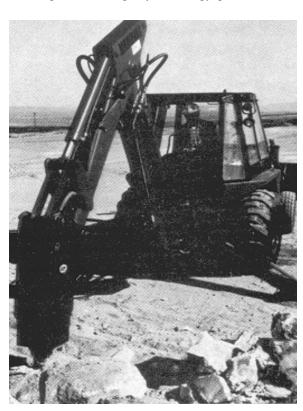
Figure 5-7. Boom-mounted breaker

(1) Boom-mounted breakers. Boom-mounted impact breakers are applicable for both full- and partial-depth removals where production rates required are greater than can be economically achieved by the use of hand-held The boom-mounted breakers are somewhat similar to the hand-held breakers except that they are considerably more massive. The tool is normally attached to the hydraulically operated arm of a backhoe or excavator (Figure 5-7) and can be operated by compressed air or hydraulic pressure. The reach of the hydraulic arm enables the tool to be used on walls at a considerable distance above or below the level of the machine. Boommounted breakers are a highly productive means of removing concrete. However, the blow energy delivered to the concrete should be limited to protect the structure being repaired and surrounding structures from damage resulting from the high cyclic energy generated. Saw cuts

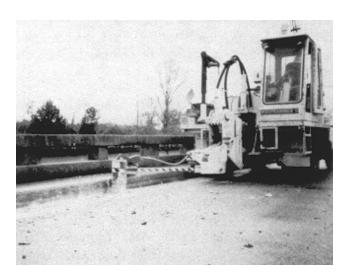
Figure 5-8. Spring-action hammer (mechanical sledgehammer)

(2) Spring-action hammers. Spring-action hammers (sometimes referred to as mechanical sledgehammers) are boom-mounted tools that are applicable for breaking concrete pavements, decks, walls, and other thin members where production rates required are greater than can be economically achieved with the use of hand-held breakers. Hammers are more applicable for total demolition of a concrete member than for removal to rehabilitate or repair. The arm of the hammer is hydraulically powered, and the impact head is spring powered. The spring is compressed by the downward movement of the arm of the backhoe or excavator and its energy released just prior to impact. There are truck units available that make it easier to move between projects. The operation of the hammer and advancement of the truck during removal are controlled from a cab at the rear of truck (Figure 5-8). The blow energy delivered to the concrete should be limited to protect the structure being repaired and surrounding structures from damage caused by the high cyclic energy Saw cuts should be employed at removal boundaries to reduce the occurrence of feathered edges. The concrete that remains may be damaged (microcracking) along with the exposed reinforcing steel.

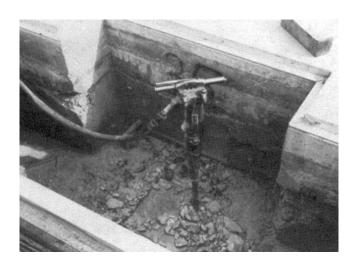
Figure 5-9. Hand-held breaker

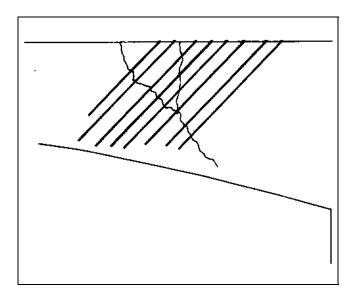
Figure 6-1. Crack repair using conventional reinforcement with drillholes 90 deg to the crack plane

- c. Procedure.
  - (1) Conventional reinforcement.
- (a) This technique consists of sealing the crack, drilling holes 19 mm (3/4 in.) in diam at 90 deg to the crack plane (Figure 6-1), cleaning the hole of dust, filling the hole and crack plane with an adhesive (typically epoxy) pumped under low pressure 344 to 552 KPa (50 to 80 psi), and placing a reinforcing bar into the drilled hole. Typically, No. 4 or 5 bars are used, extending at least 0.5 m (1.6 ft) on each side of the crack. The adhesive

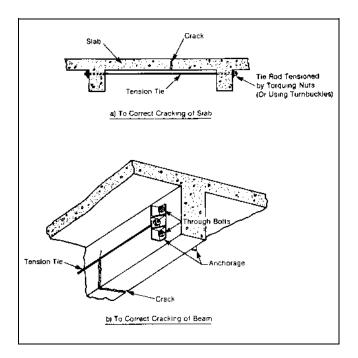
Figure 6-2. Crack repair with use of external prestressing strands or bars to apply a compressive force

(2) Prestressing steel. This technique uses prestressing strands or bars to apply a compressive force (Figure 6-2). Adequate anchorage must be provided for the prestressing steel, and care is needed so that the problem will not merely migrate to another part of the structure. The effects of the tensioning force (including eccentricity) on the stress within the structure should be carefully analyzed. For indeterminate structures posttensioned according to this procedure, the effects of secondary moments and induced reactions should be considered.

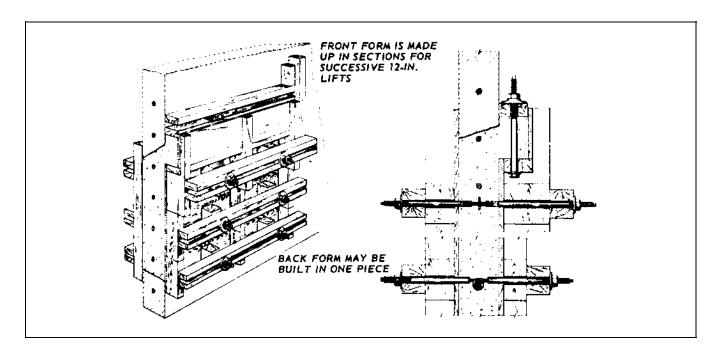
Figure 6-3. Detail of form for concrete replacement in walls after removal of all unsound concrete

- (3) Forming will usually be required for massive repairs in vertical surfaces. The front form and the back form, where one is required, should be substantially constructed and mortartight. The back form may be assembled in one piece, but the front panel should be constructed as placing progresses so that the concrete can be conveniently placed in lifts. The contact surface should be dry at the time of patching. Small, thin repairs (less than 50 mm (2 in.) thick) should receive a bonding coat while thicker placements usually do not require a bonding coat (see paragraph 5-3a(2)(f)). The surface is first carefully coated with a thin layer of mortar, not exceeding 3 mm (1/8 in.) in thickness, containing sand passing the No. 16 sieve, and having the same w/c as the concrete to be used in the replacement. Hand-rubbing the mortar into the surface is effective. Epoxy resin

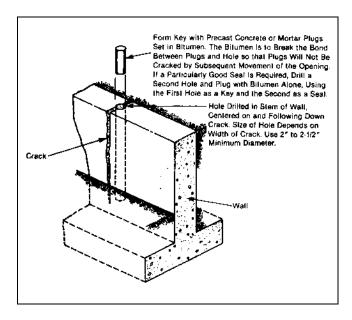
Figure 6-5. Repair of crack by drilling and plugging

a. Description. Drilling and plugging a crack consists of drilling down the length of the crack and grouting it to form a key (Figure 6-5).

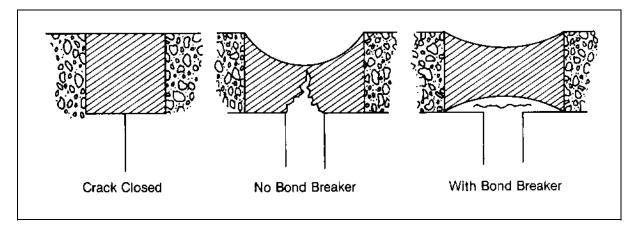
Figure 6-6. Effect of bond breaker involving a field-molded flexible sealant

- (1) A bond breaker should be provided at the bottom of the slot to allow the sealant to change shape without a concentration of stress on the bottom (Figure 6-6). The bond breaker may be a polyethylene strip, pressure sensitive tape, or other material which will not bond to the sealant before or during cure.

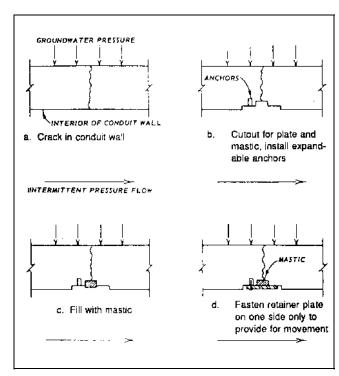
Figure 6-8. Repair of crack by use of a retainer plate to hold mastic in place against external pressure

necessary to cut the concrete surface adjacent to the crack and to place the retaining cap flush with the original flow lines (Figure 6-8).

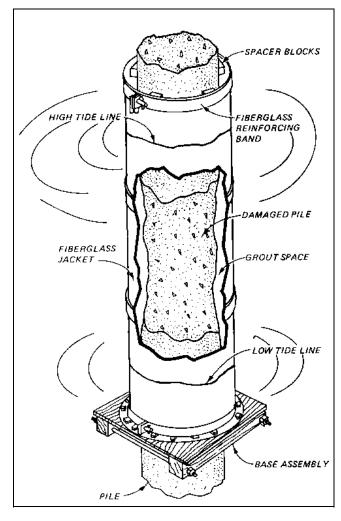
Figure 6-9. Typical preformed fiberglass jacket being used in repair of a concrete pile

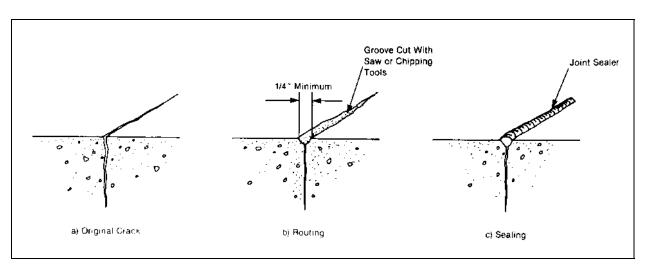
Figure 6-10. Repair of crack by routing and sealing

a. Description. This method involves enlarging the crack along its exposed face and filling and sealing it with a suitable material (Figure 6-10). The routing operation may be omitted but at some sacrifice in the permanence of the repair. This is the simplest and most common method for sealing dormant cracks.

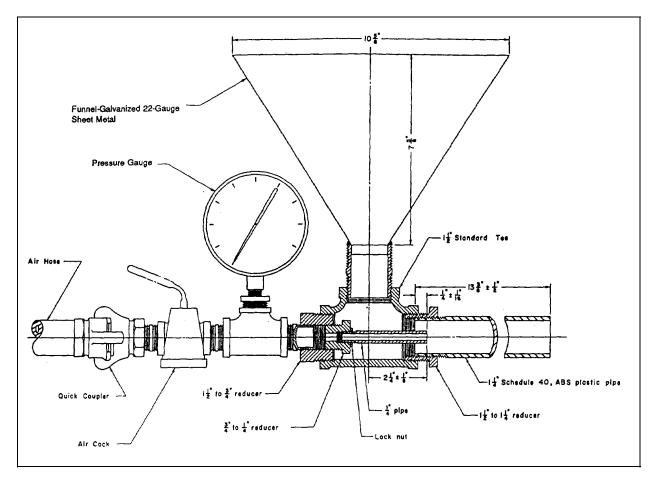
Figure 6-11. Mortar gun for concrete repair (U.S. Army Engineer Division, Missouri River 1974)

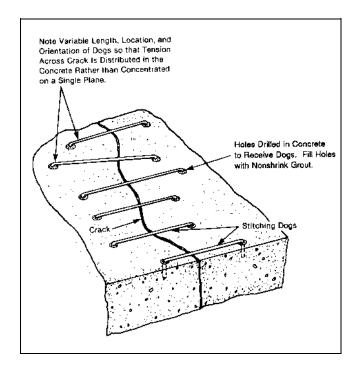
Figure 6-13. Repair of a crack by stitching

- a. Description. This method involves drilling holes on both sides of the crack and grouting in stitching dogs (U-shaped metal units with short legs) that span the crack (Johnson 1965) (Figure 6-13).
- b. Applications and limitations. Stitching may be used when tensile strength must be reestablished across major cracks. Stitching a crack tends to stiffen the structure, and the stiffening may accentuate the overall structural restraint, causing the concrete to crack elsewhere. Therefore, it may be necessary to strengthen the adjacent

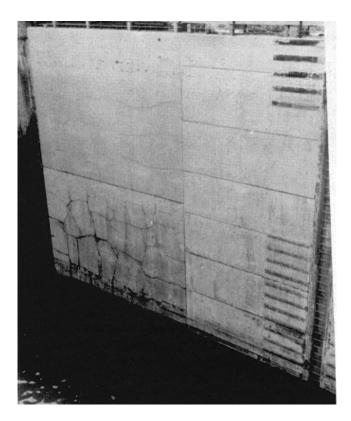
Figure 8-3. Concrete cracking in resurfaced monolith (left) compared to reconstructed monolith, Lock No. 1, Mississippi River

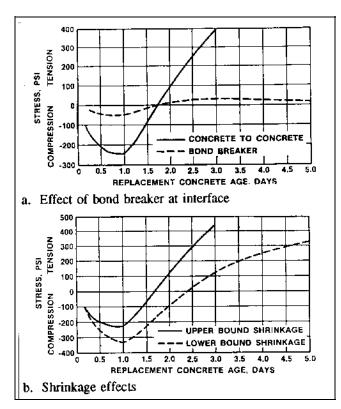
Figure 8-4. Results of a finite element analysis of a typical lock wall resurfacing

(a) A finite element analysis of a typical lock wall resurfacing (Norman, Campbell, and Garner 1988) also demonstrated the effect of restraint by the existing concrete. Under normal conditions of good bond between the two concretes, stress levels sufficient to cause cracking in the replacement concrete developed within about 3 days (Figure 8-4a). In comparison, a bond breaker at the interface resulted in almost no stress in the replacement concrete. The analysis also indicated that shrinkage was a significant factor (Figure 8-4b). Even the lower bound shrinkage resulted in tensile stresses in excess of 2.1 MPa (300 psi).

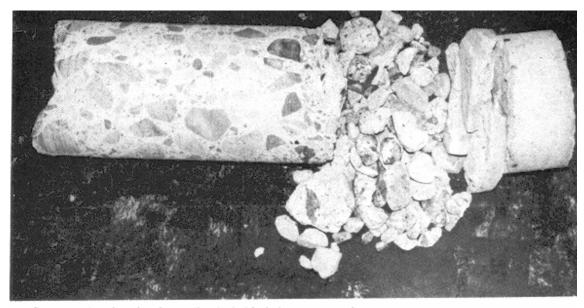
a. Concrete deterioration immediately behind shotcrete overlay

- (d) The concrete in the walls of Lower Monumental Lock has an inadequate air-void system to resist damage caused by freezing and thawing while critically saturated. After approximately 10 years in service, the concrete had deteriorated to the point that the aggregate was exposed. After laboratory tests and a full-scale field test which demonstrated that a 10-mm (3/8-in.)-thick latex-modified fiberglass-reinforced spray-up coating had the potential to meet repair requirements, which included time constraints on the lock downtime that precluded conventional concrete replacement (Schrader 1981), the lock walls were repaired (Figure 8-10) in 1980. In March 1983 several small isolated areas of debonded coating (less than 1 percent of the total area) were identified in the lock. The coating in these locations was removed and the areas resprayed similar to the original repair. Also, a fairly large debonded zone in monolith 11 was repaired. September 1983 inspection reported the original coating to

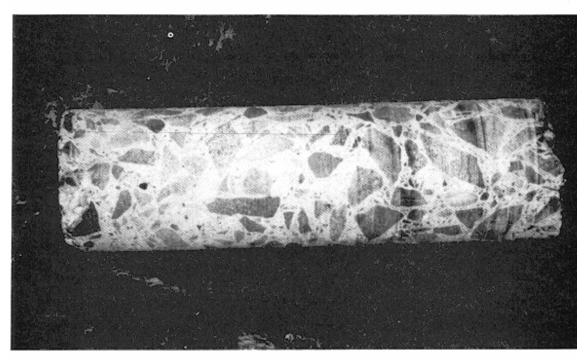
b. Concrete not refaced with shotcrete

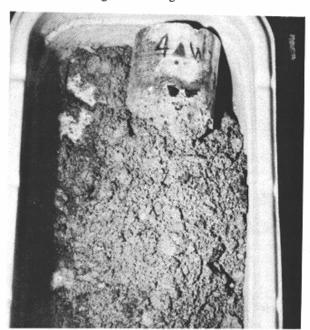
b. After freezing and thawing

Figure 8-8. Combination shotcrete and concrete core before and after 35 cycles of freezing and thawing in a saturated condition

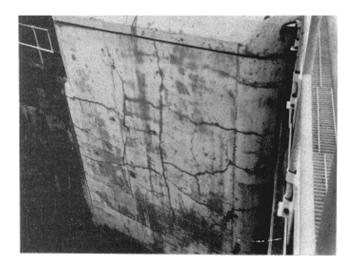
Figure 8-16. Typical cracking in miter gate monoliths resurfaced with cast-in-place concrete, Troy Lock, Hudson River (Miles 1993)

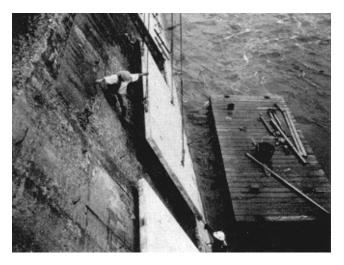
Figure 8-17. Installing precast concrete panels used to overlay the back side of the river wall at Troy Lock, Hudson River (Miles 1993)

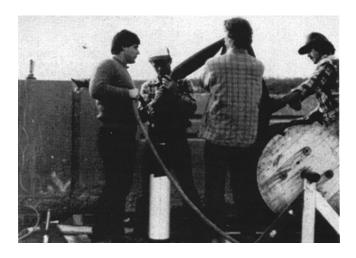
Figure 8-23. Two-component natural rubber and elastomer coated nylon sleeve being inserted into drill hole, Bagnell Dam

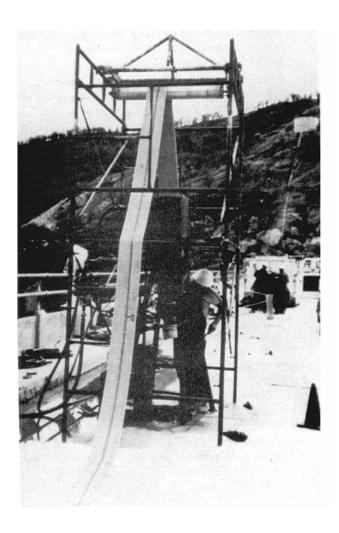
Figure 8-24. Inversion apparatus for installing tube in drill hole, Pine Flat Dam

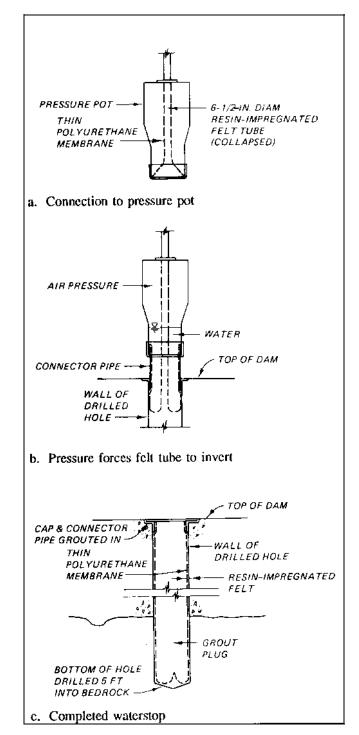
Figure 8-25. Remedial waterstop installation, Pine Flat Dam

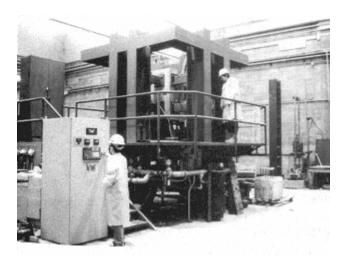
Figure 8-28. Remedial waterstop test apparatus

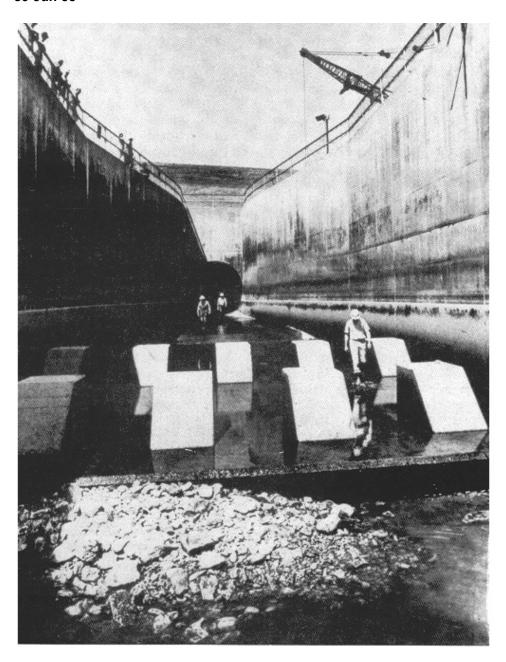
Figure 8-30. Stilling basin dewatered for inspection, Pomona Dam

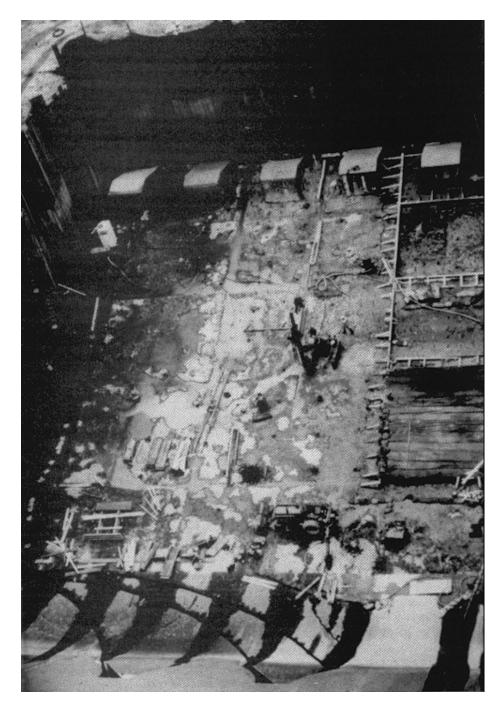
Figure 8-34. General view of repair operations, Kinzua Dam, 1974

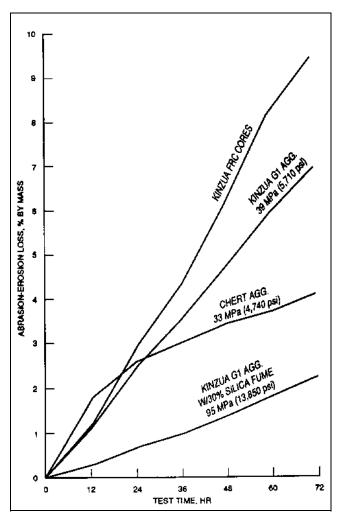
Figure 8-35. Results of selected abrasion-erosion tests. Kinzua Dam

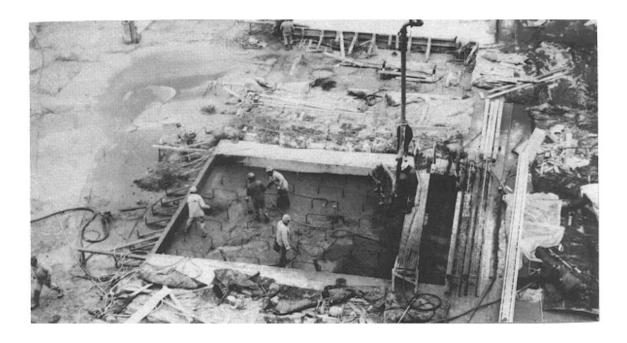
Figure 8-36. Pumping silica-fume concrete into the stilling basin from the top of the right training wall, Kinzua Dam

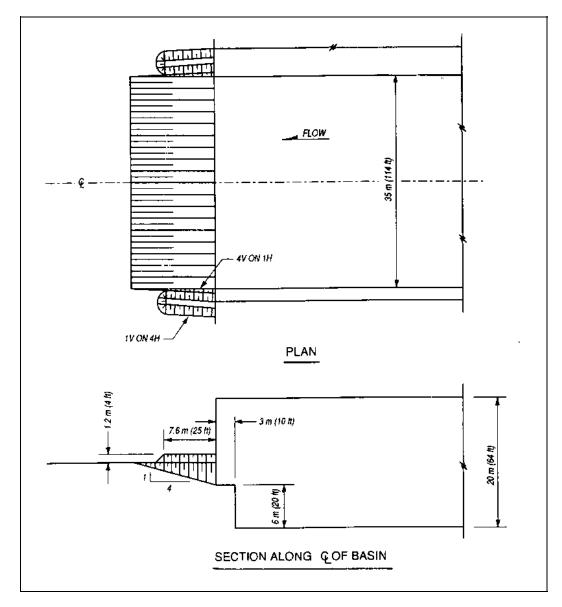
Figure 8-37. Stilling basin wall extension fills, Dworshak Dam

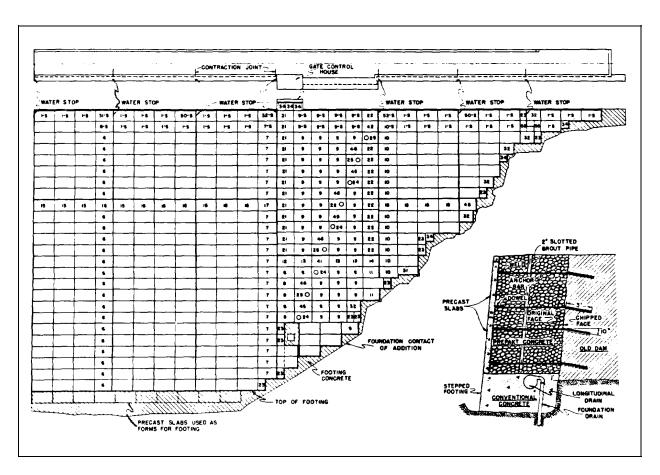
Figure 8-38. Footing and slab layout, south half of Barker Dam (from Davis, Jansen, and Neelands 1948)

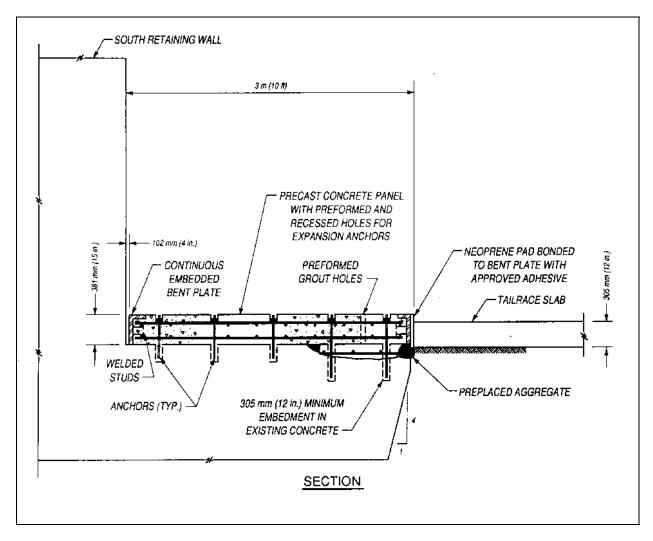
Figure 8-39. Underwater repair of concrete spalling, Gavins Point Dam

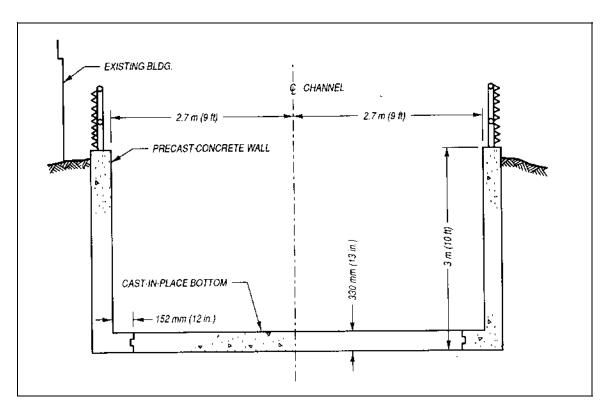
Figure 8-45. Typical channel repair section, Placer Creek (after Hacker 1986)

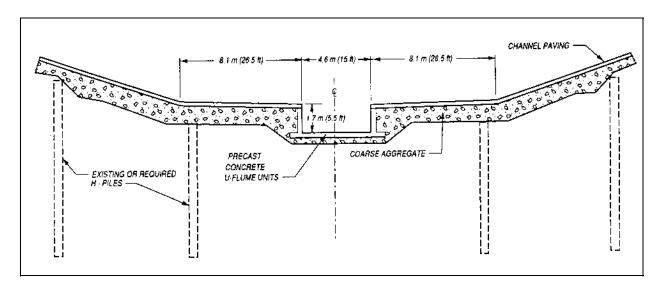
Figure 8-46. Cross section of precast low-flow channel, Blue River Channel (after Mitscher 1992)

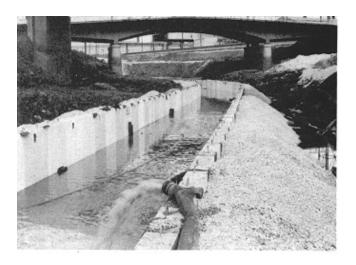
Figure 8-48. Diversion of river water through channel sections. Blue River Channel

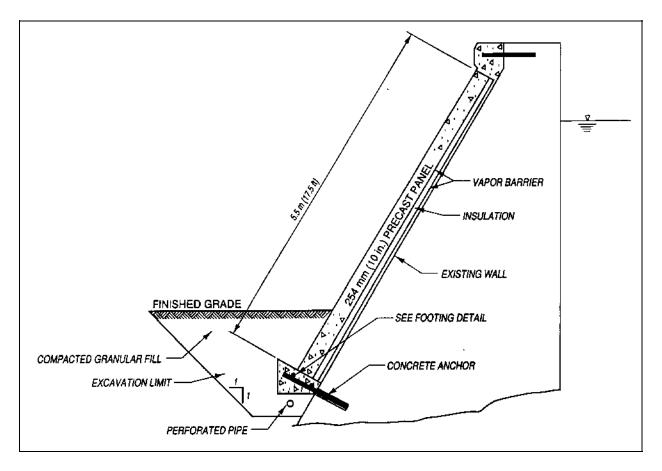
Figure 8-49. Typical repair section, Joliet Channel Wall

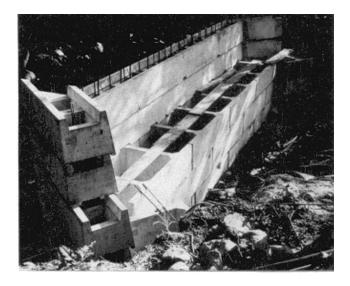
Figure 8-51. Top view of precast abutment prior to backfilling, Ulsterville Bridge

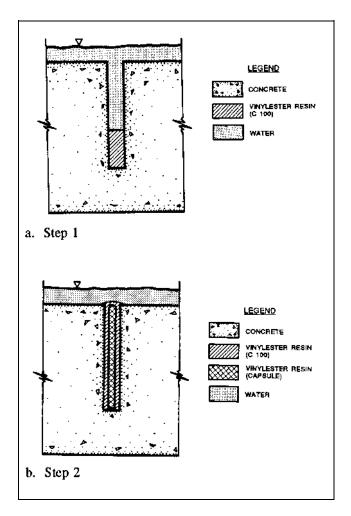
Figure 8-56. Two-step procedure for anchor installation under submerged conditions

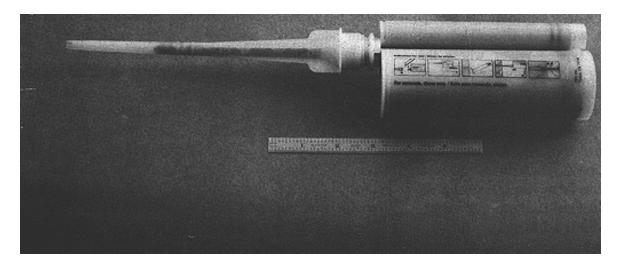
Figure 8-57. Paired disposable cartridges and static mixing tube

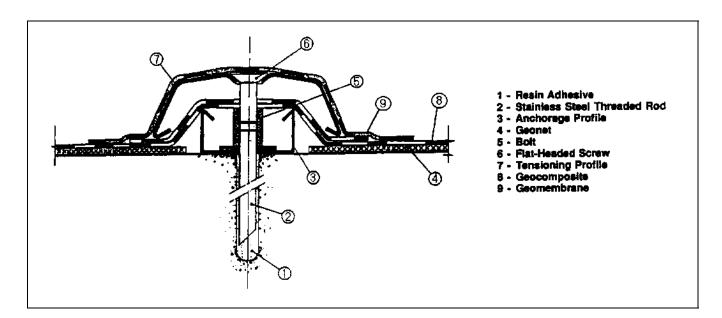
Figure 8-58. Detail of vertical anchorage and drainage profile

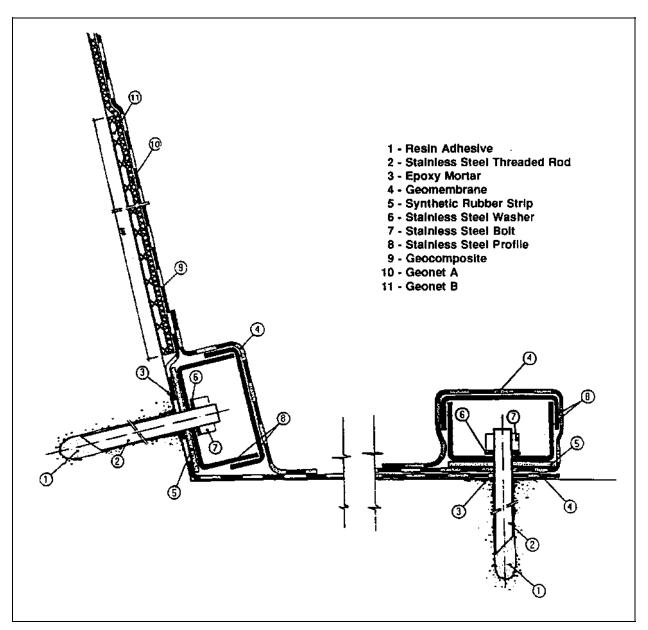
Figure 8-59. Detail of sealing profiles

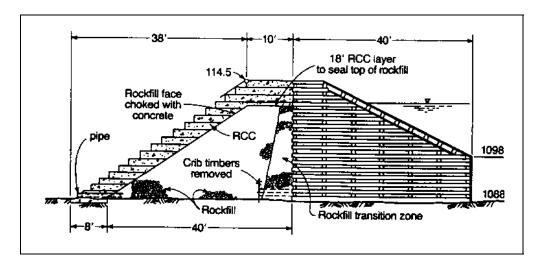
Figure 8-63. Section through modified dam, Ocoee Dam No. 2 (Hansen 1989)

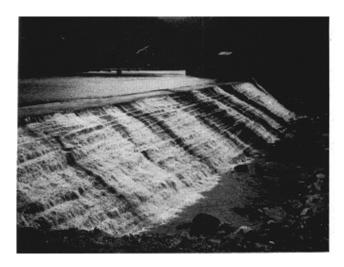
Figure 8-64. Condition of RCC following periodic overtopping, Ocoee No.2 Dam

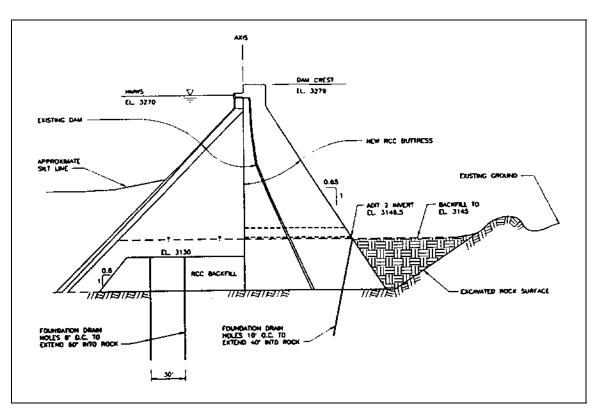
Figure 8-70. Littlerock Dam modification (Bischoff and Obermeyer 1993)
